Boeing Service Bulletin 757-27A0139 Thomson Saginaw Bulletin 7900897

757 Position 1 & 8 T/E Flap Ballscrew Overhaul and Exchange Programs

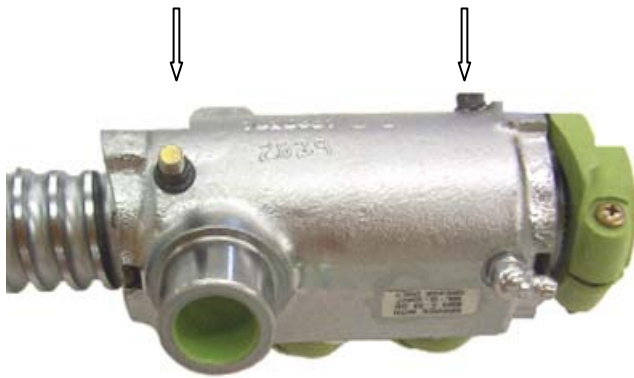
PROBLEM: Initial design determined to have insufficient secondary load path needed to ensure stabilization in the event of a primary load path failure.

ADDITIONAL DEFLECTORS INSTALLED

SOLUTION: Modification of ballscrew (installation of two additional deflectors) to achieve sufficient secondary load path.
